## **Recommendations for laying the “SE/NM WINDPROOF SYSTEM (SEW/NMW)”**

**TEST REPORT No. 355101**

**“Windproof system for SE pedestals”**

**resistance to uniformly-distributed static loading  
(negative pressure) of raised access flooring by simulated  
wind suction**

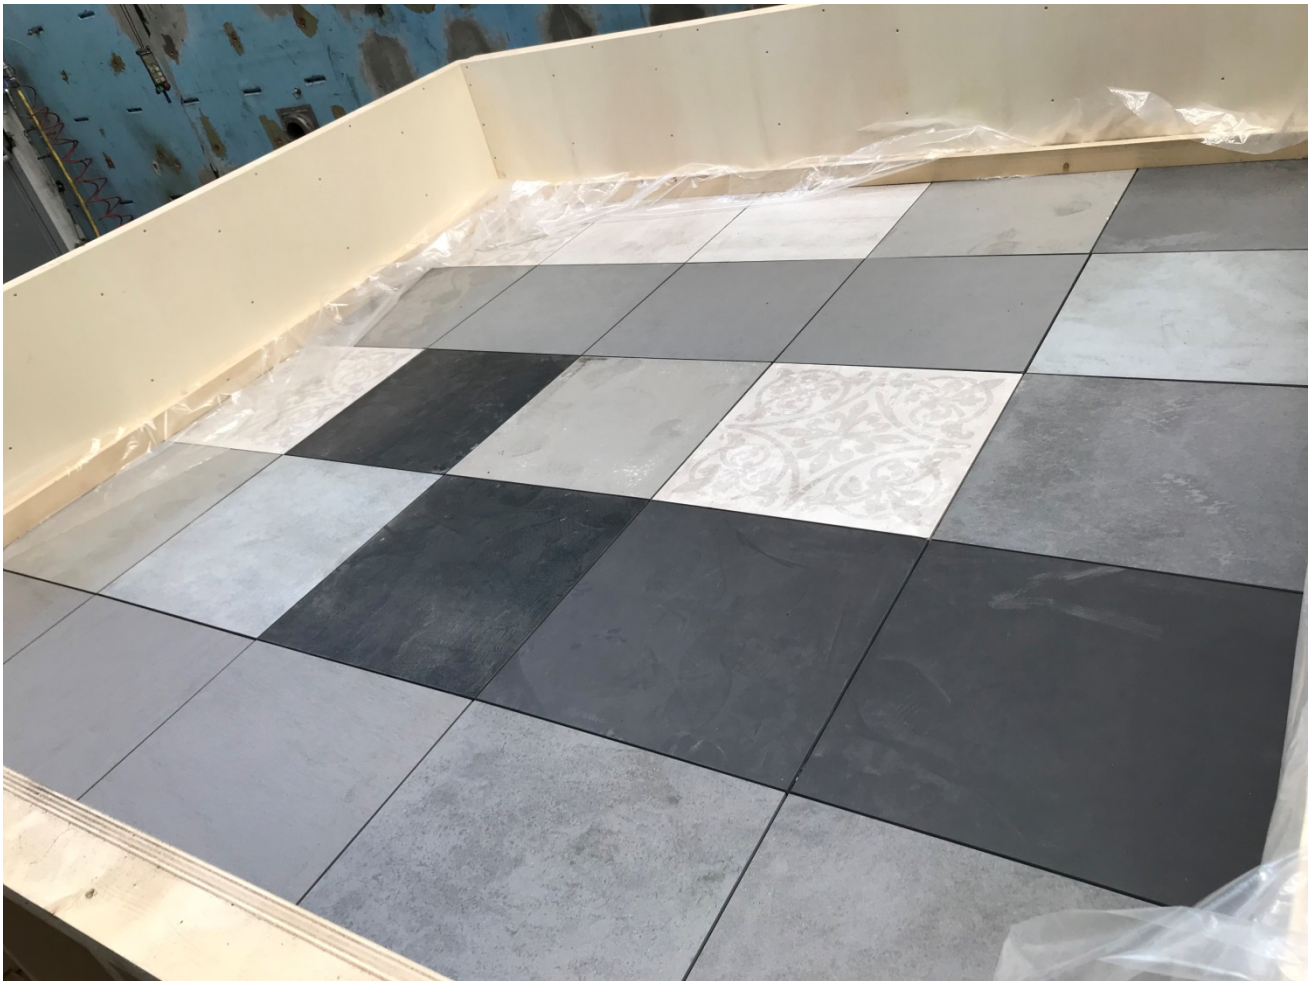
The test sample comprises a portion of a raised access floor, overall size 3000 mm × 3000 mm, composed of:

- porcelain floor tiles, plan-view dimensions 596 mm × 596 mm and thickness 20 mm;
- single-tab metal clips for fastening tiles to pedestals;
- understructure of plastic stringerless pedestals with tilting head complete with plastic gasket.

**Sample photo**

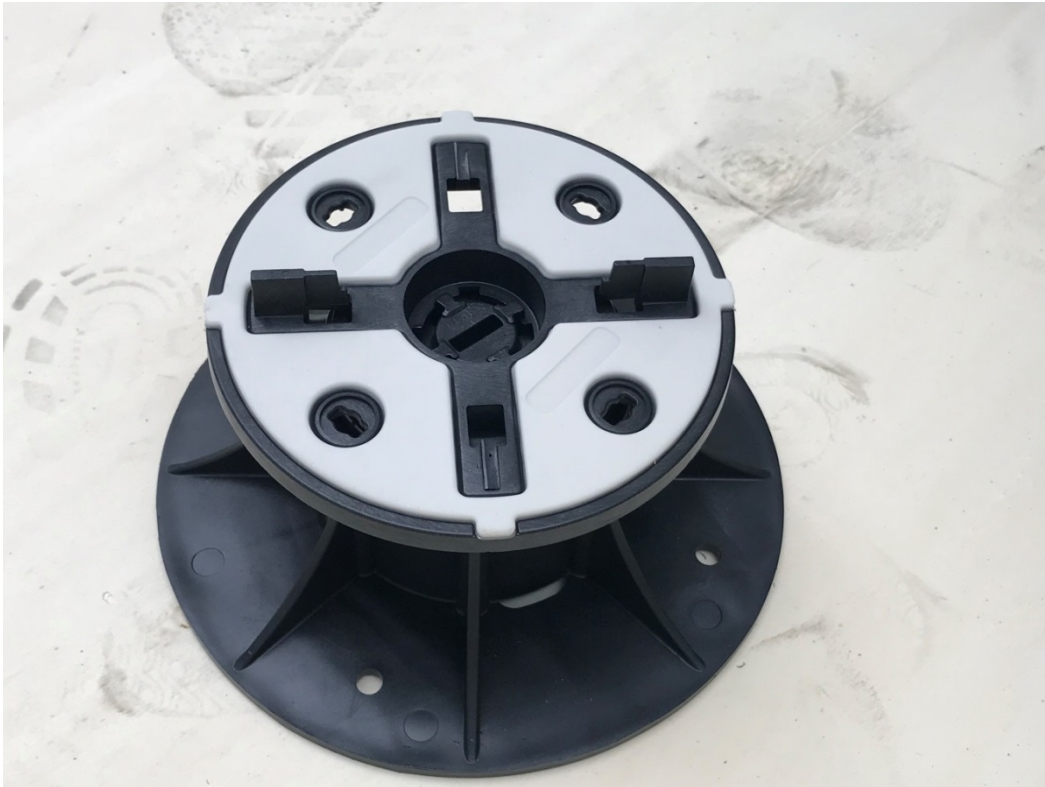
**Photo of a pedestal**

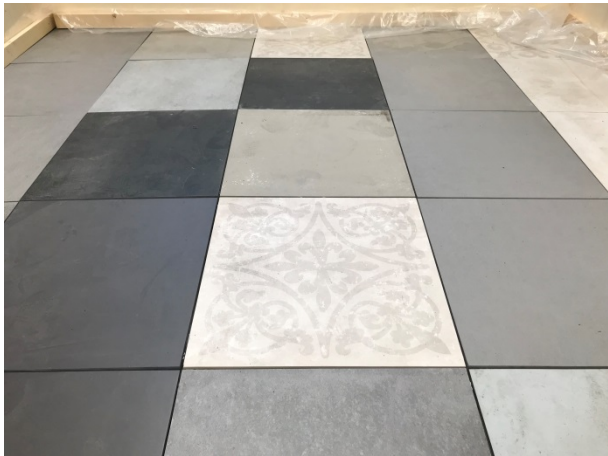
The sample was fitted to the test rig and underwent the wind suction test with measurement of deformation whilst loaded.

More specifically, the test was performed in successive steps of 100 Pa until visible failure of the sample occurs.

**Photo of sample during testing**

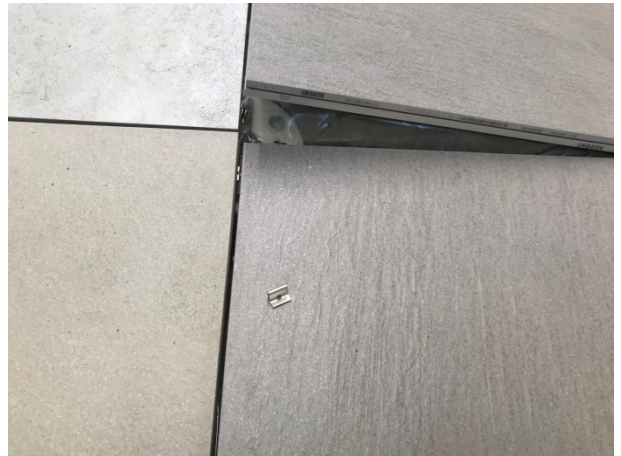
The sample resisted up to 600 Pa without visible damage, the test continued up to 700 Pa, negative pressure at which the floor tiles were detached following breakage of the lugs holding the pedestal components together.

**Close-up of detachment**

**the sample resisted up to 600 Pa without visible damage,  
the test continued up to 700 Pa, negative pressure at which the  
floor tiles were detached following breakage of the lugs holding  
the pedestal components together**

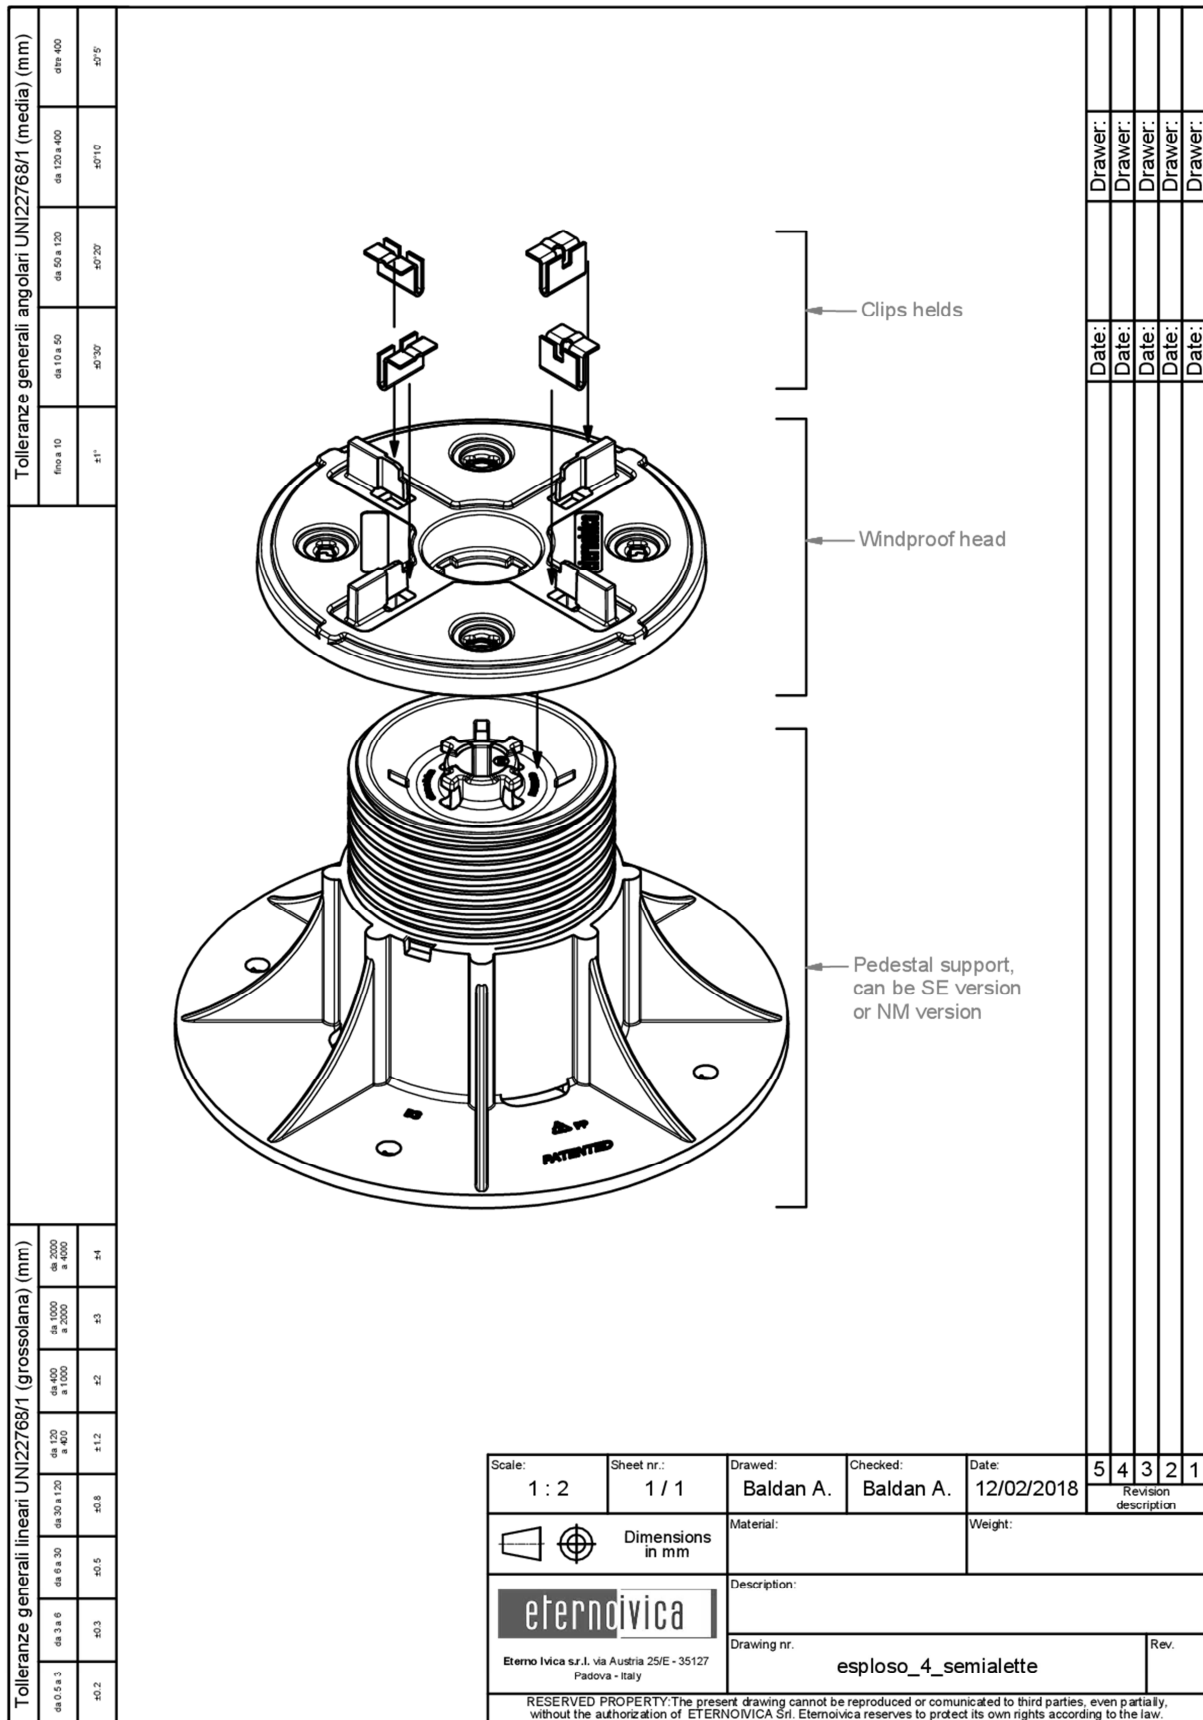
**ANNEX "A"**  
**AL TEST REPORT No. 355101**

**sample technical documentation**

Further details of the sample's characteristics can be seen in the Customer-supplied schematic drawings in Annex "A" herein.
